BUILDING INSPECTION REPORT

52 El Cerrito Place
Jemez Springs, New Mexico 87025

Report Number: **10672**

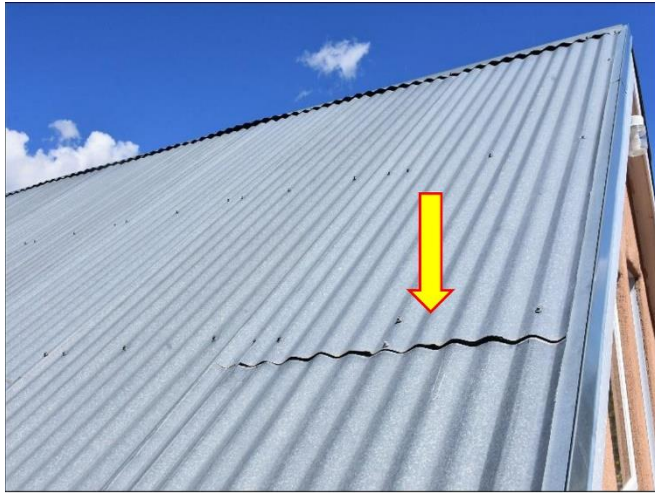
1. Corrugated zinc panel roof was installed with recycled materials and may need immediate attention to prevent leaks.

10. **Improve:** Consult with a Plumber & Mechanical Contractor to assist with the cost of Maintenance & Remedies.
11. **Improve:** Consult with a Roofing Contractor to assist with the cost for future Maintenance on the Propanel roof.
12. **Improve:** Consult with a Stucco Contractor to assist with the cost repairing and touch-ups.

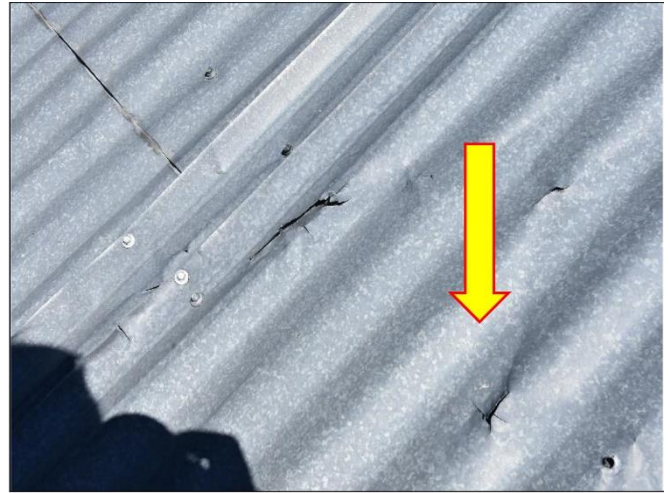
2. Corrugated zinc panel roof was installed with recycled materials showing tear and small holes will need immediate repairs.

- The assessment for drainage is an “A-” Grade.*
- G. Roof:** The original roof is installed with recycled corrugated galvanize panels. Maintenance is necessary along with further inspection by a roofer. Gutters & downspouts are recommended for drainage.

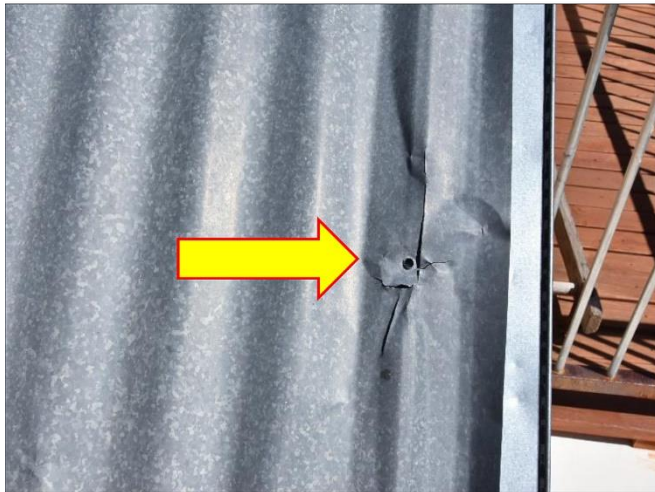
3. Example of some of the damages to the corrugated zinc panel roof.

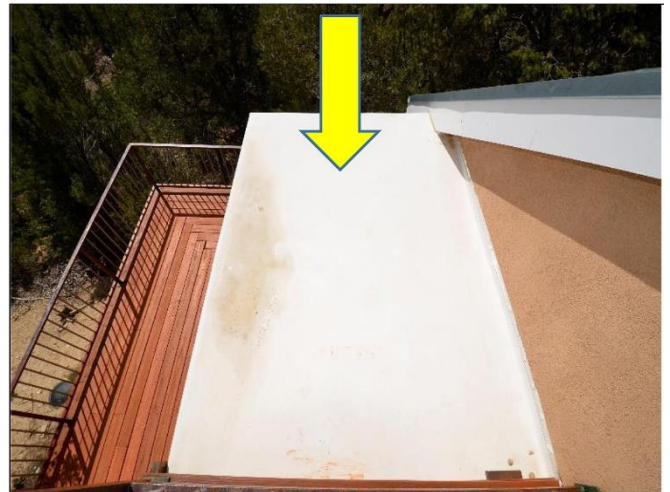
4. TPO roof membranes were installed at both ends of the upper deck roof and are in **Satisfactory Condition**.

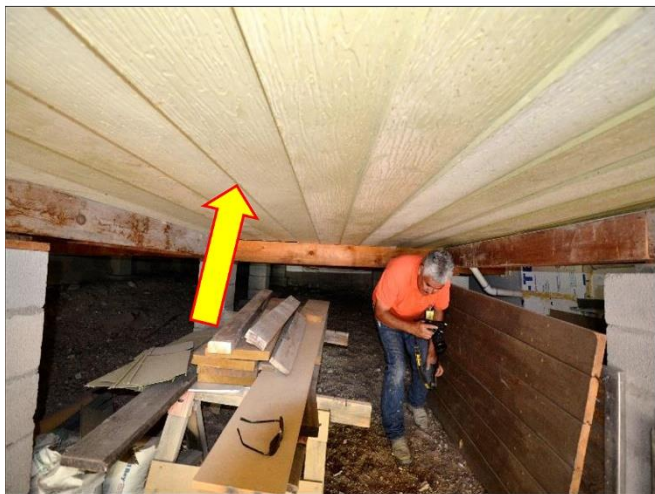
5. Ceiling coverings by using recycled aluminum siding to cover the rafters conceals assumed insulation but cannot be verified.

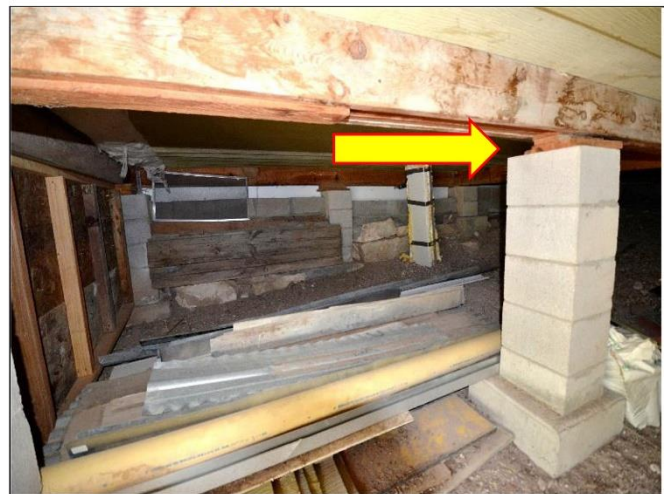
- The assessment for these systems is a “A” Grade.*
- B. Foundation:** The foundation under the open Crawl Space are stem walls with footings that cannot be seen without digging with CMU block piers that will need steel strong-ties for better support. A Pest Control Company should be consulted to make sure that there are no damages from radiant & insects.

6. CMU Block piers throughout the Crawl Space should have steel strong ties engineered for better seismic supports. Shims were loose.

2. House will need minor detailing on the interiors; and a few doors & windows will need minor adjustments.
3. Door to the 3rd floor Bedroom is stuck and needs to be repaired.
4. Portal Viga posts will need high pressure grout added underneath each post as per ICC & State UBC Codes.
5. Some of the switch plates will need to be exchange with proper plates as per ICC and State UEC codes.
6. Refrigerator needs a filter exchange before taking possession of the House/ Cabin.
7. All Exterior exposed woodwork should be oil-seal with Behr Products at least every 3-years to prevent weathering.
8. Crawl Space should be closed in with doors to prevent animals from causing damages.
9. Crawl Space beam to CMU block piers should be fastened with steel strong ties for seismic support.

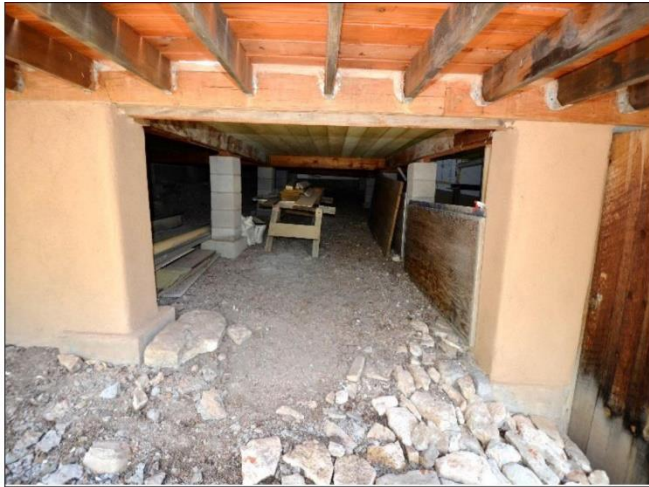
7. Opening to the Crawl Space that should have doors installed for security purposes to keep animals from damaging the space within this rural environment.

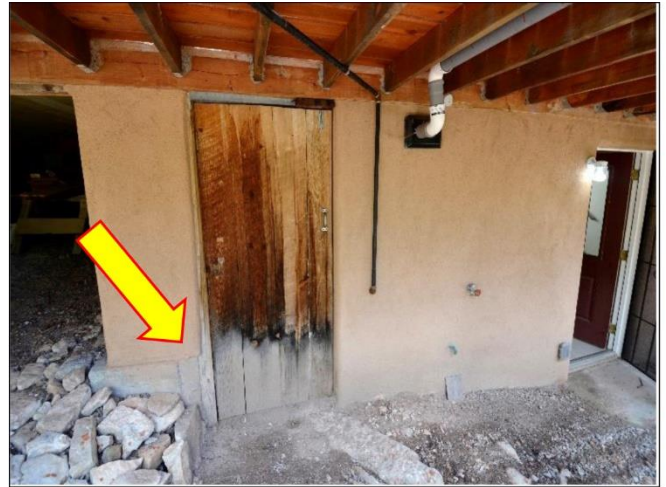
8. Separate door to the Mechanical Area under the House will need an oil seal to prevent weathering.

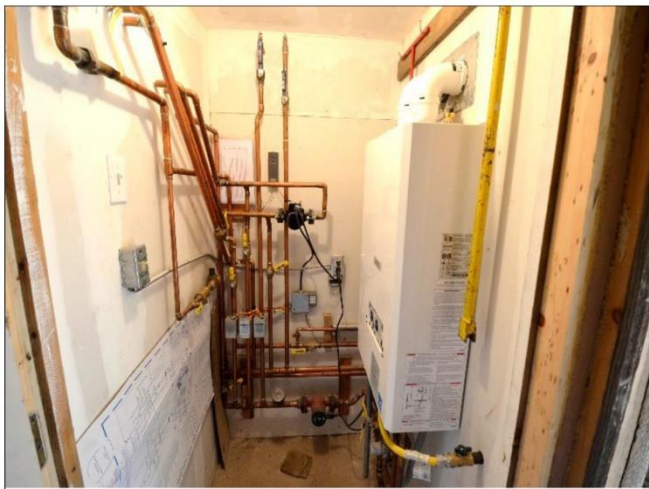
9. Mechanical closet setup for domestic and radiant heating by using Propane fuel

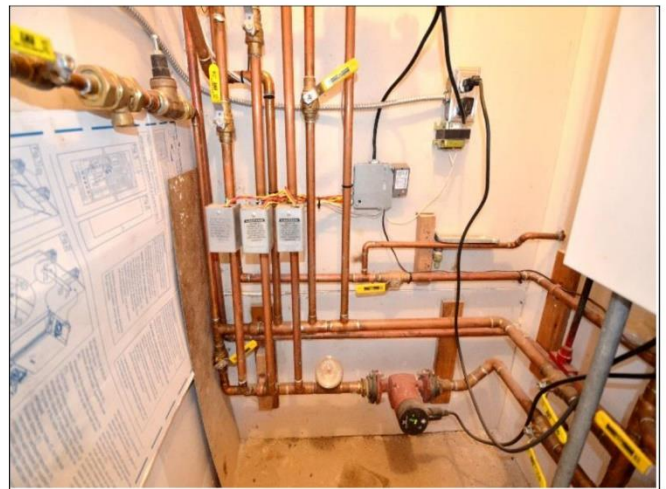
10. Mechanical closet showing a very professional setup by using copper pipes.

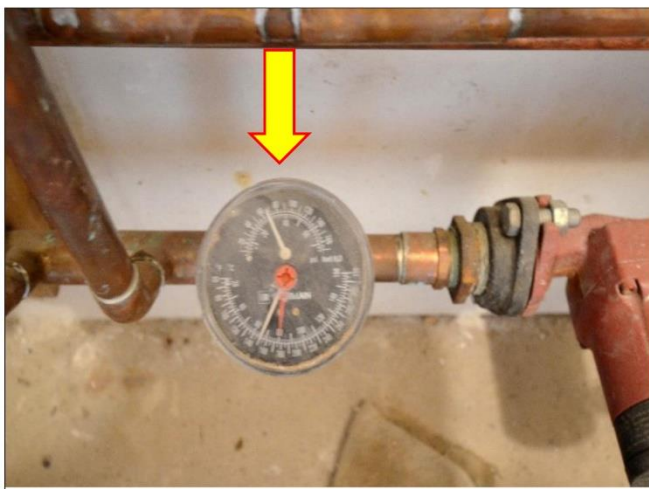
11. Embassy Industries instant H₂O heater's pressure & temperature gauge the is set and working very well.

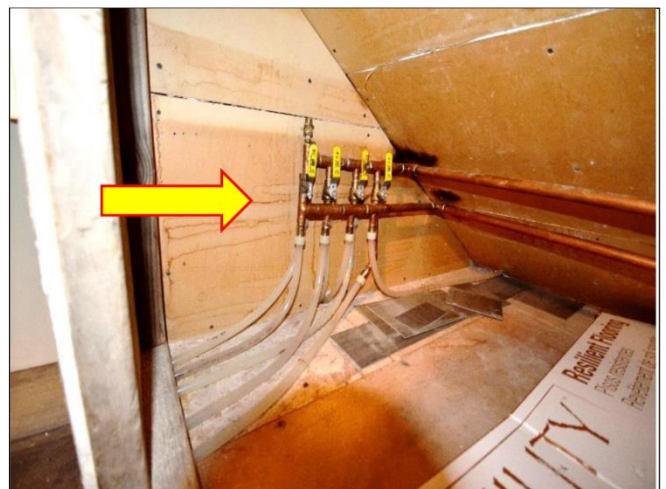
12. Manifold found under the staircase between the 2nd and 3rd floors showing Wirsbo that is a superior radiant tubing system.

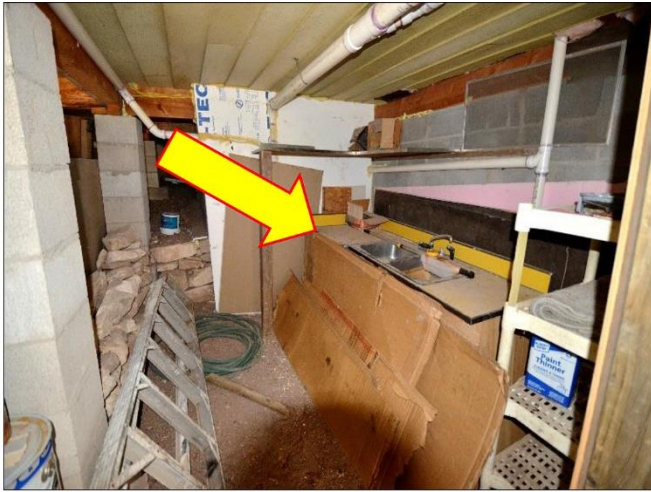
13. Crawl Space showing a discarded sink & counter that should be removed.

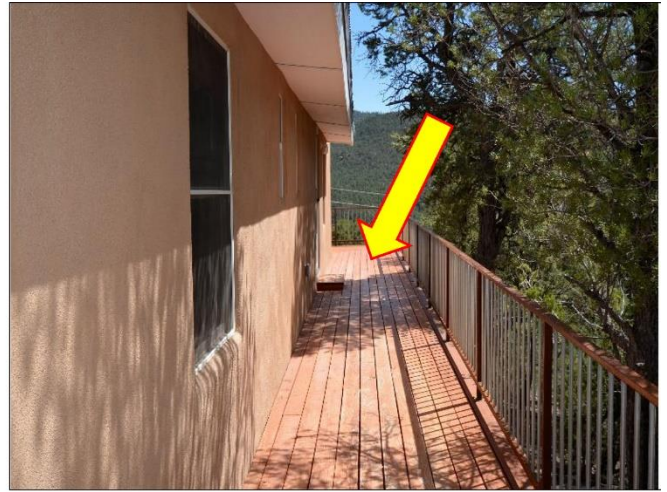
14. 2nd Floor decking that is dry and will need an oil seal with Behr Products to prevent weathering at least every 3-years.

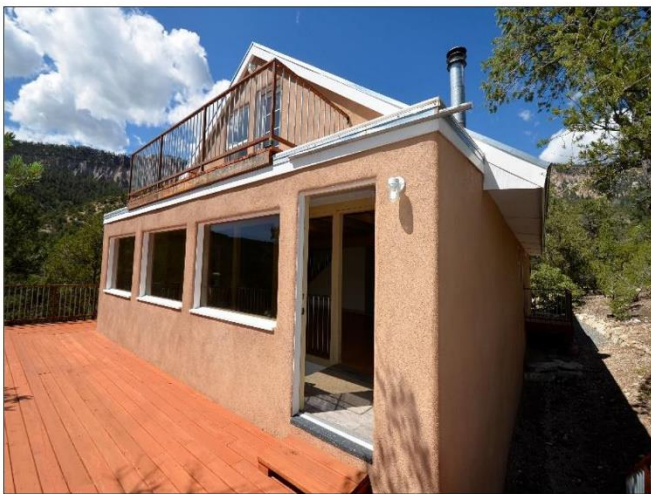
15. 2nd Floor decking that is dry and will need an oil seal with Behr Products to prevent weathering at least every 3-years

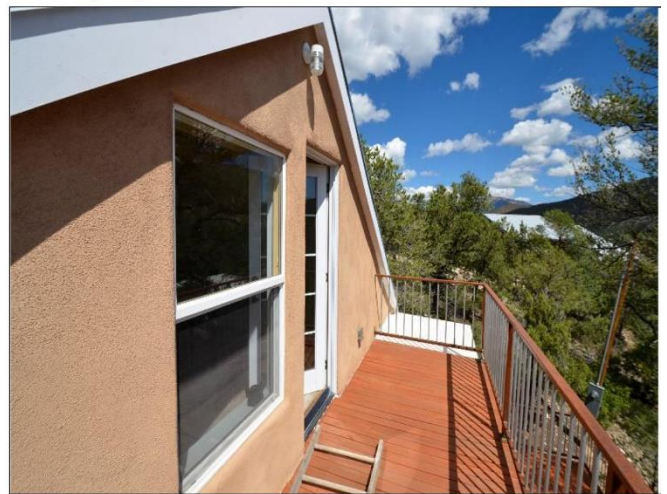
16. 3rd Floor decking that is also dry and will need an oil seal with Behr Products to prevent weathering at least every 3-years

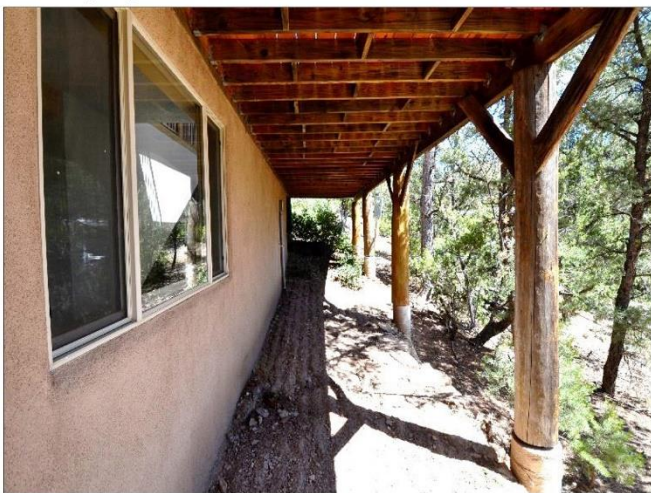
- The assessment for these elements is an “A-” Grade.*
- E. Portals & Posts:** Decks are supported by Vigas posts, beams and the exposed woodwork will need oil-sealing at least every 3-years to prevent deterioration. All Vigas round posts are anchored above and to concrete piers and it’s recommended to use high pressure grout underneath for better support.

17. Under deck at the ground level with Viga Posts that should have high strength grout packed under the posts to prevent rust to the 1/2" bolts.

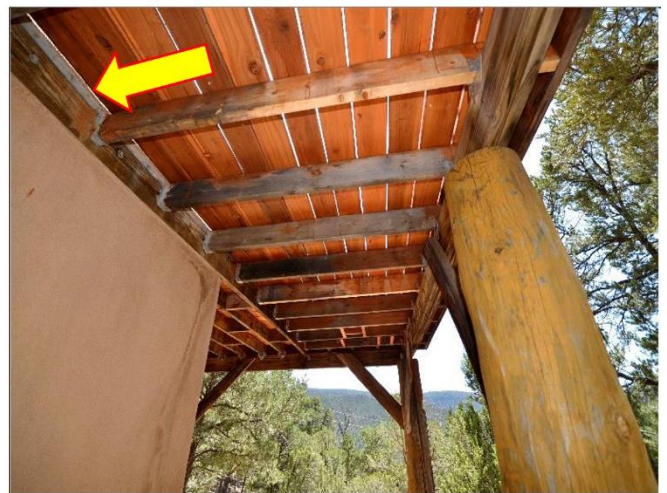
18. Under deck at the ground level with Viga Posts that should be refinished as well. Ledger is lag screwed to the wall and is apparently safe.

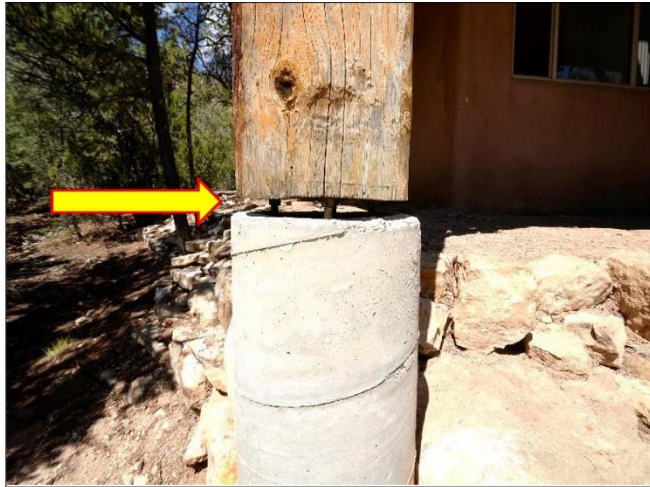
19. Example of Viga Posts that should have high strength grout packed under all of the posts to the concrete piers to prevent rusting to the 1/2" bolts

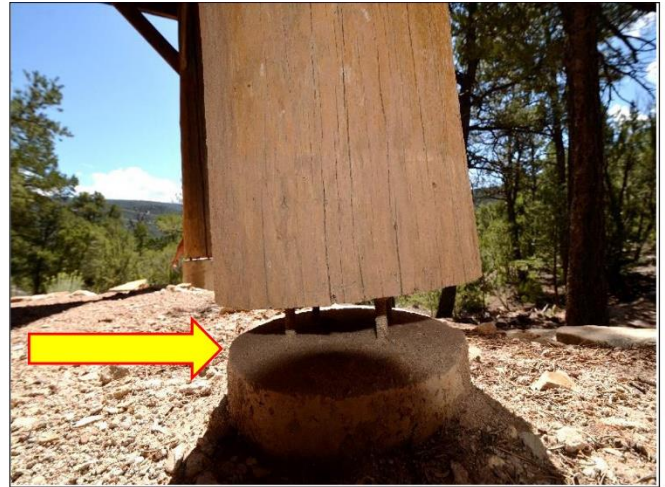
20. Example of Viga Posts that should have high strength grout packed under all the posts to the concrete piers to prevent rusting to the 1/2" bolts.

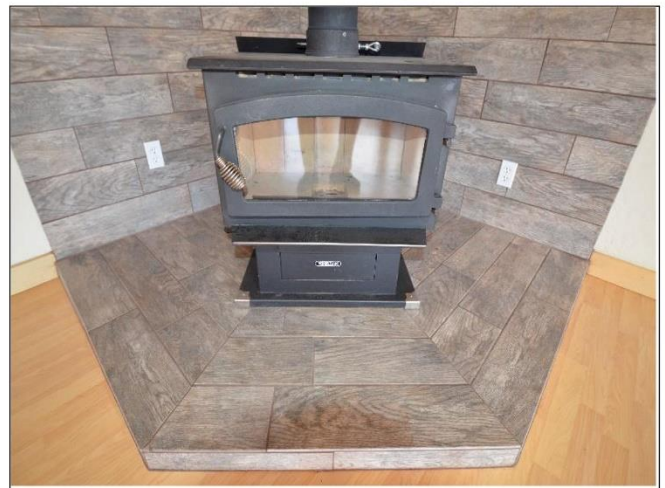
22. Wood burning stove found in the Living Room is in **Satisfactory Condition**.

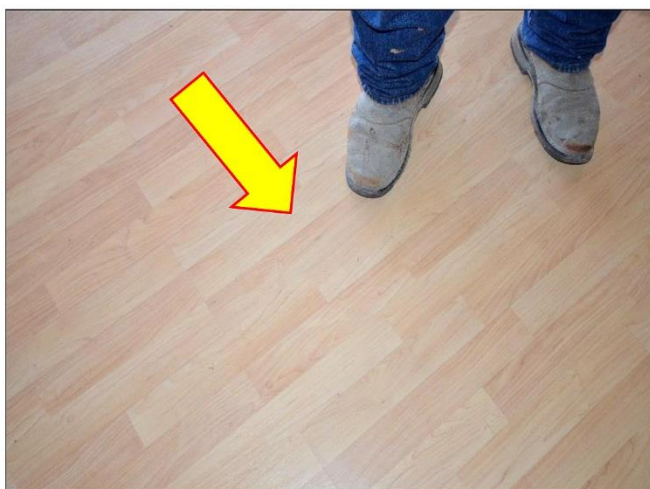
23. Some areas of the Pergo flooring that are slightly spongy and it's recommended in the future to exchange the flooring material with a better surface.

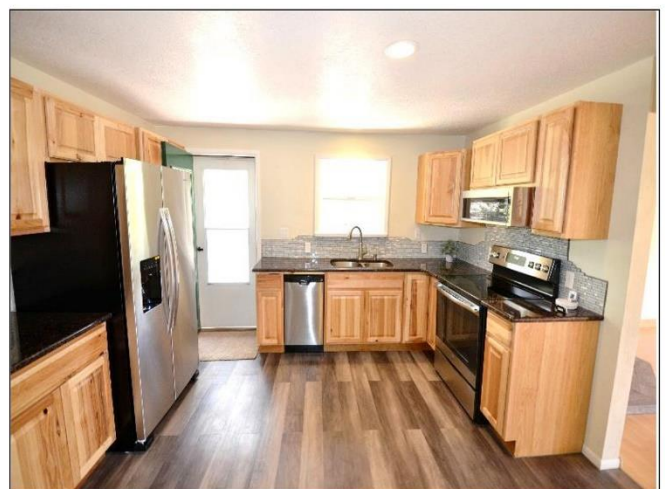
24. Kitchen, all electric with quality cabinets and vinyl flooring are in **Satisfactory Condition**. Split Floor level from the Kitchen to Living can be problematic.

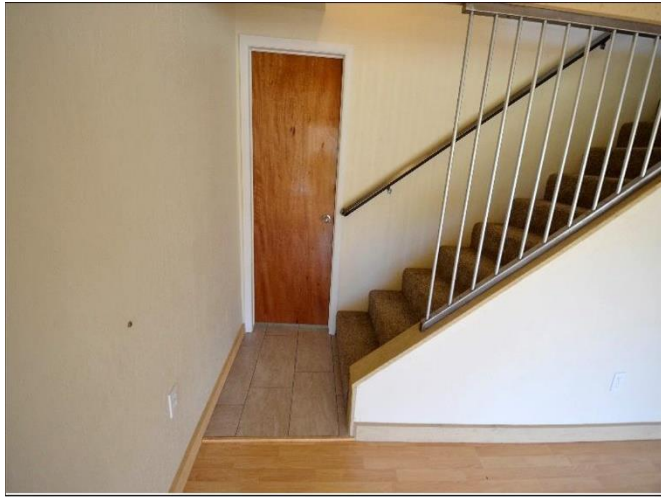
25. Staircase to the 3rd floor have a 3-way switching as per code and is in **Satisfactory Condition**.

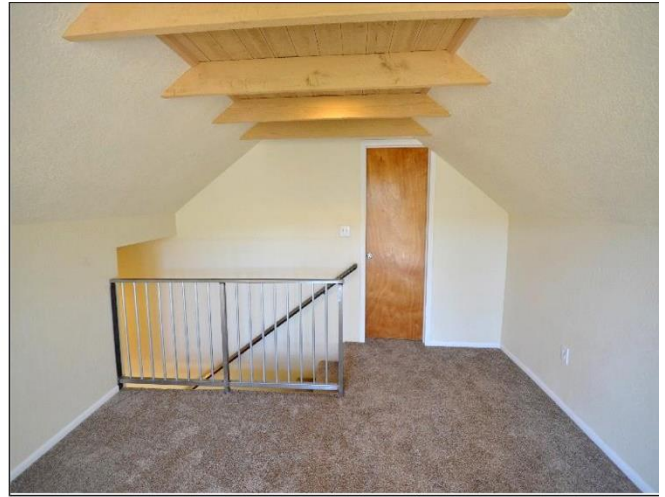
26. 3rd floor landing with hand railing is in **Satisfactory Condition**

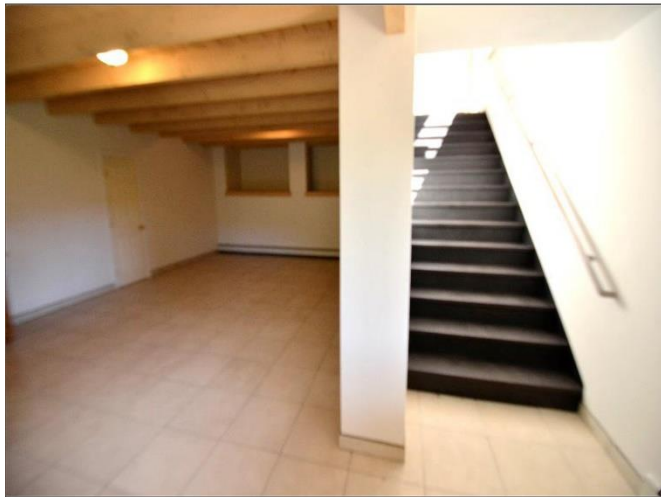
27. Main 4-foot Staircase from Basement to 2nd Floor with a single handrail and 3-way switching as per code is in **Satisfactory Condition**.

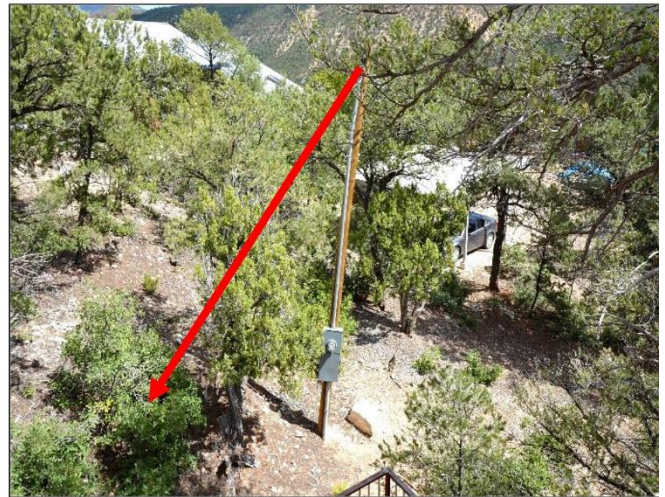
28. Utility pole should have a back-cable support by PNM to secure it from leaning.

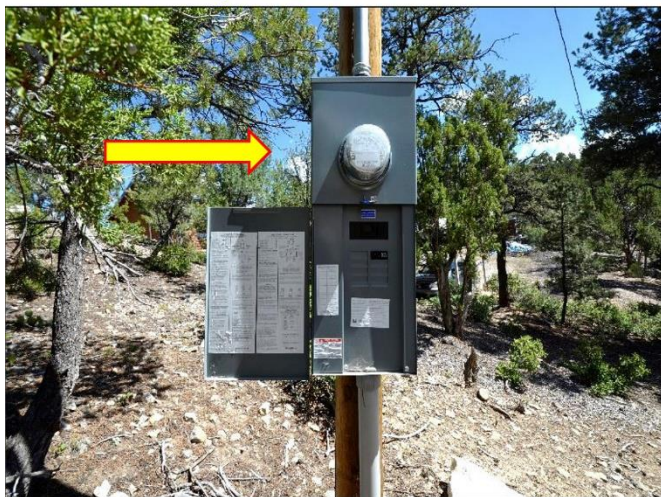
29. Utility PNM Service Meter with Main 200Amp Discount is in **Satisfactory Condition**.

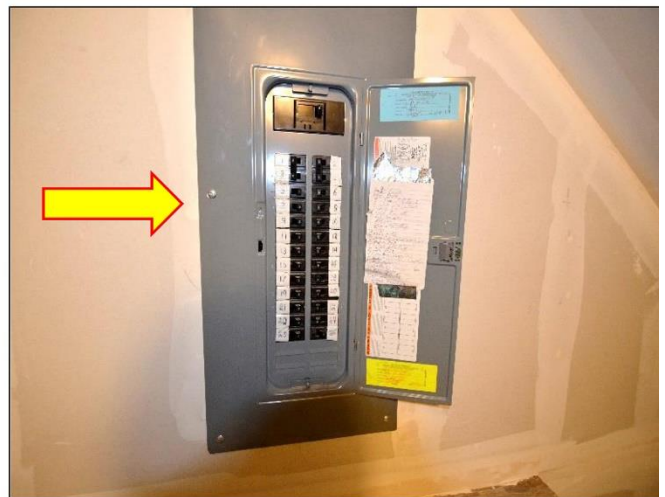
30. Electric 200Amp Panel found under the Main Staircase on the Basement level is in **Satisfactory Condition**.

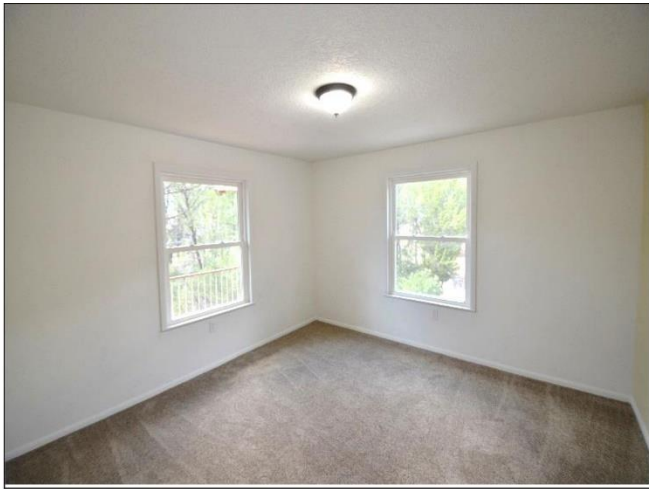
31. 2nd Floor Bedroom with carpeting and CertainTeed Vinyl windows are in **Satisfactory Condition.**

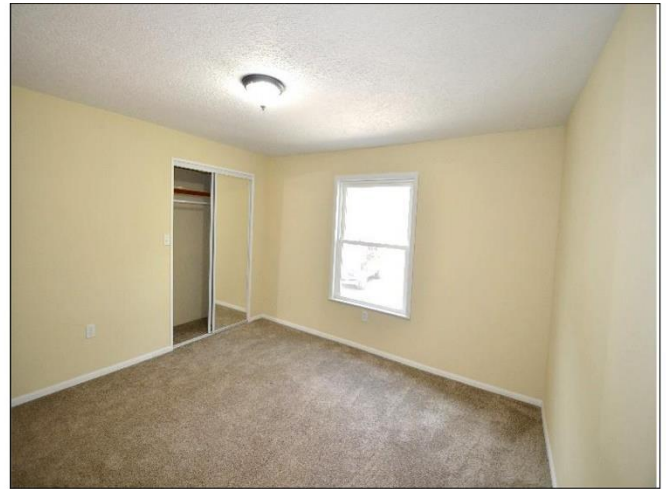
32. 2nd Floor Master Bedroom with carpeting and CertainTeed Vinyl windows are in **Satisfactory Condition.**

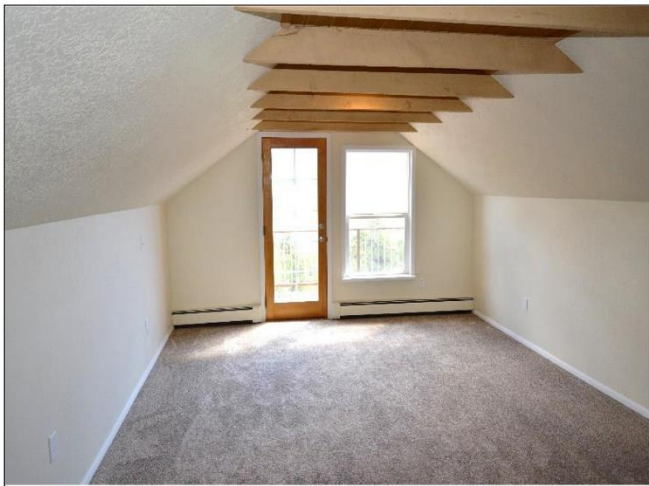
33. 3rd Floor Balcony/ Office with cathedral beam ceiling, carpeting and CertainTeed Vinyl window and glass door to deck are in **Satisfactory Condition**

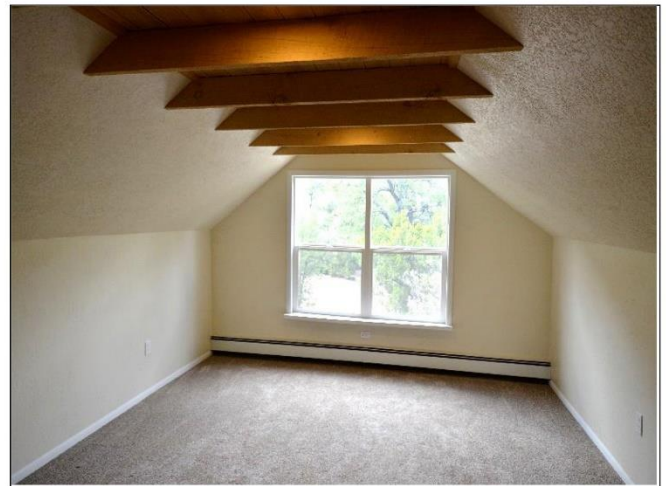
34. 3rd Floor Bedroom with cathedral beam ceiling, carpeting and CertainTeed Vinyl windows are in **Satisfactory Condition.**

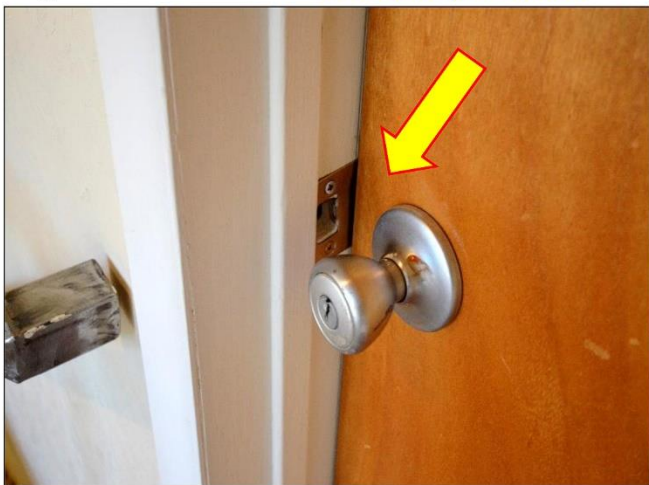
35. 3rd Floor door to Bedroom is stuck and does not close.

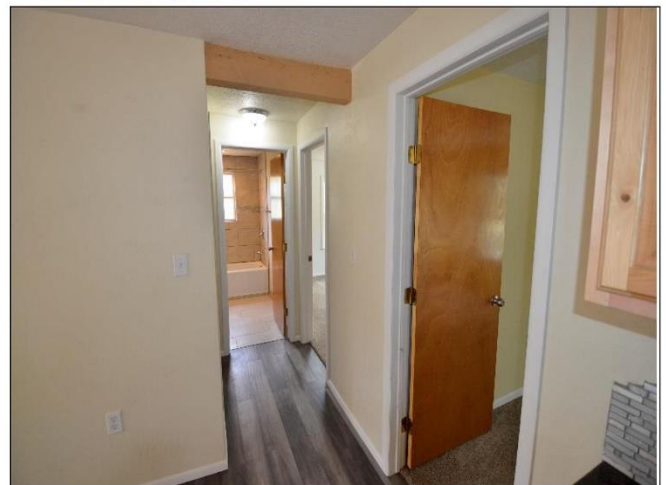
36. 2nd Floor Hallway between Kitchen and Master Suite is in **Satisfactory Condition.**

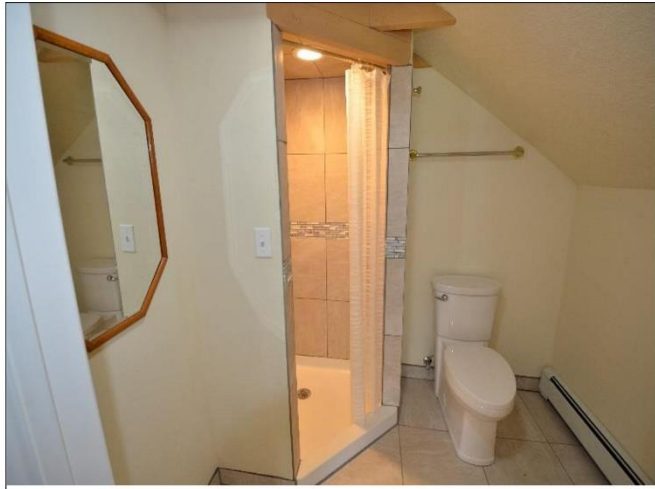
37. 3rd Floor Bathroom is in **Satisfactory Condition.**

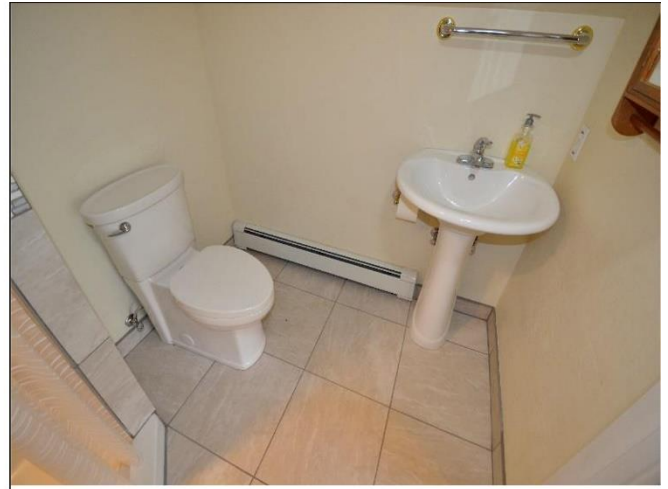
38. 3rd Floor Bathroom is in **Satisfactory Condition.**

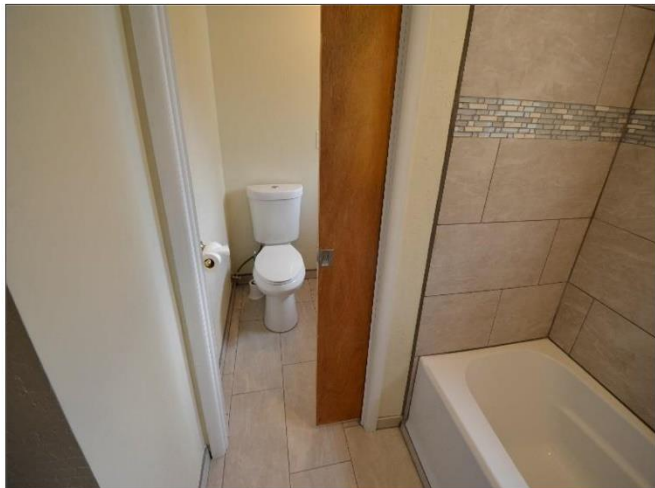
39. 2nd Floor, (Main Floor) Master Suite Bathroom is in 3/4 Bathroom is in **Satisfactory Condition.**

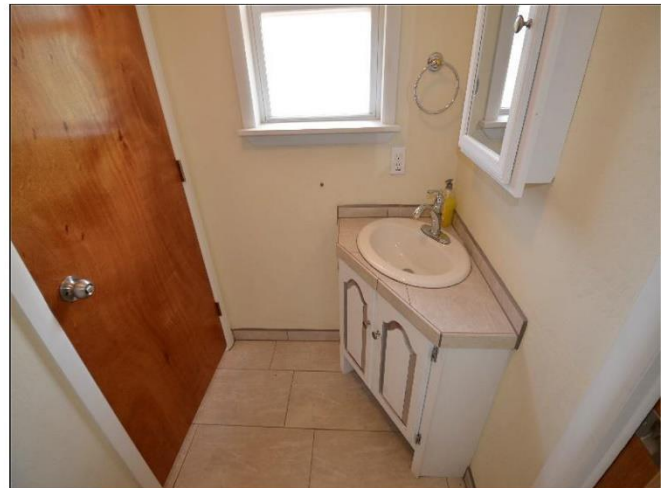
40. 2nd Floor, (Main Floor) Master Suite Bathroom with corner Vanity is in 3/4 Bathroom is in **Satisfactory Condition.**

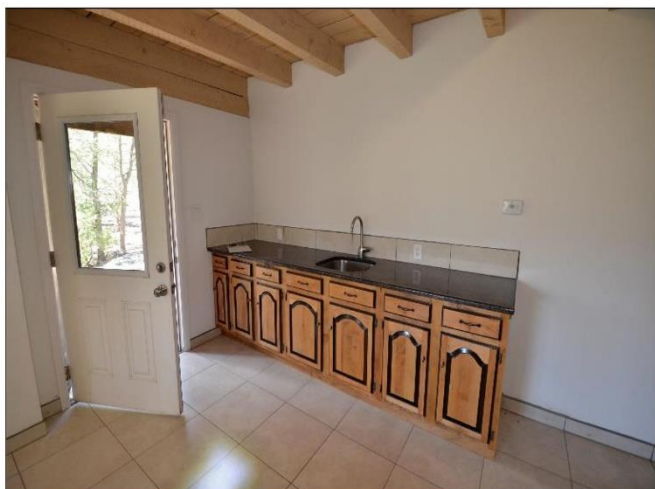
41. Basement room with tile floors and 3/4 Bathroom is in **Satisfactory Condition.**

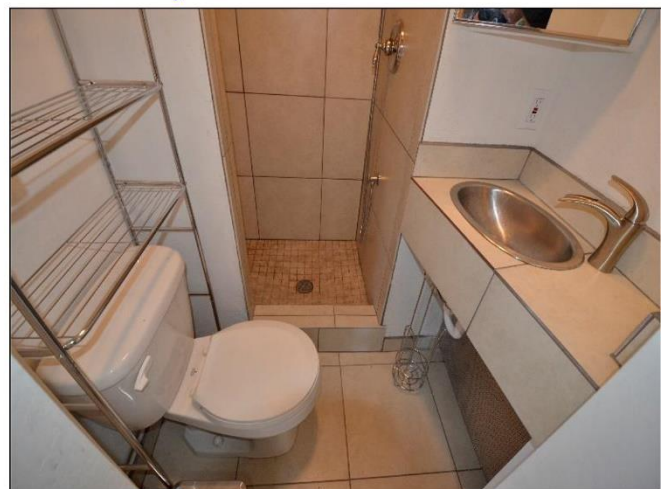
42. 3/4 Basement Bathroom is in **Satisfactory Condition.**
