BUILDING EVALUATION REPORT

206-B Gonzales Road
Santa Fe, NM 87501

Inspection Date: 9/4/19

Report Number: **10663**

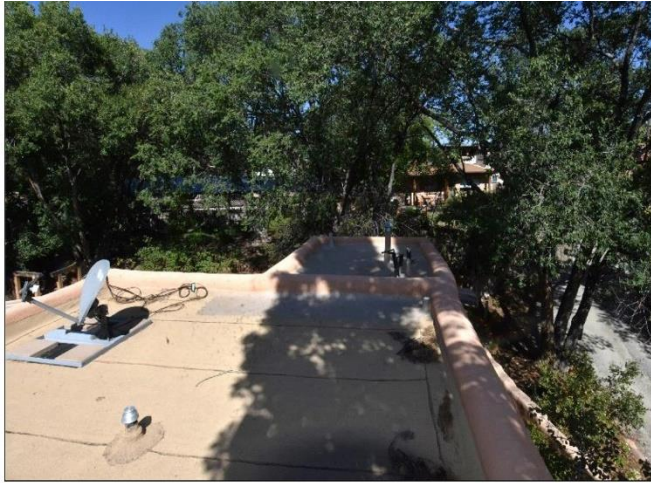
1. Torch-down roof membrane on the upper roof is in Satisfactory Condition.

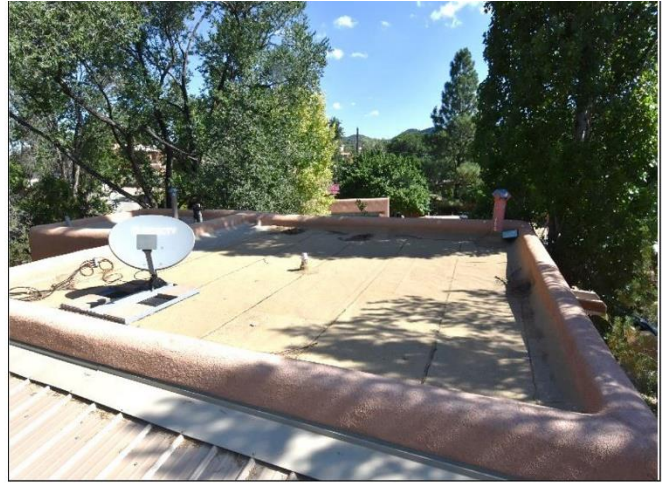
2. Propanel pitched roof attachment to parapets is in Satisfactory Condition.

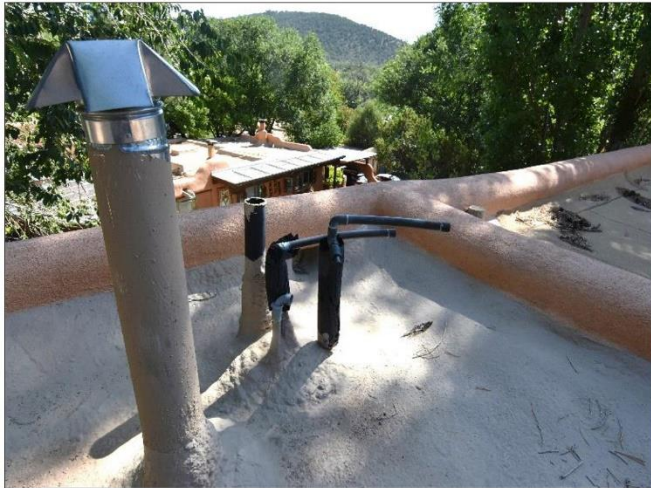
3. Small upper spray foam roof is in Satisfactory Condition.

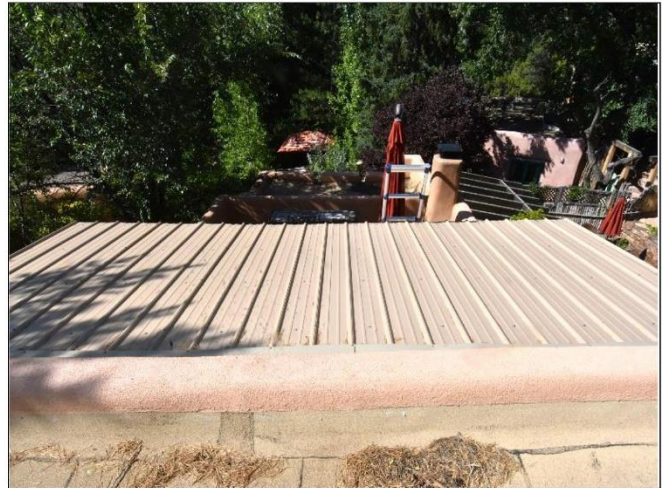
4. Propanel pitched roof over lower rooms is in Satisfactory Condition.

5. Pitched Propanel roof over the lower rooms will need minor repairs to reset some of the popping and loose screws
6. Some windows sashes are showing signs of finger joint dislodging and will need aggressive repairs and repainting.

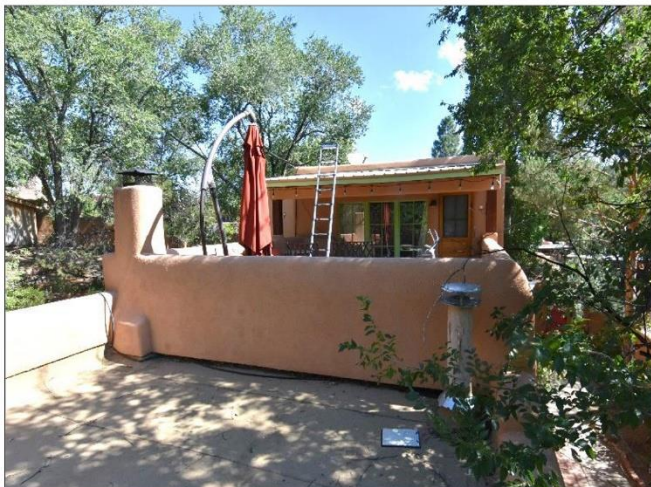
5. Lower Torch-down roof over Living and Dining rooms is in Satisfactory Condition.

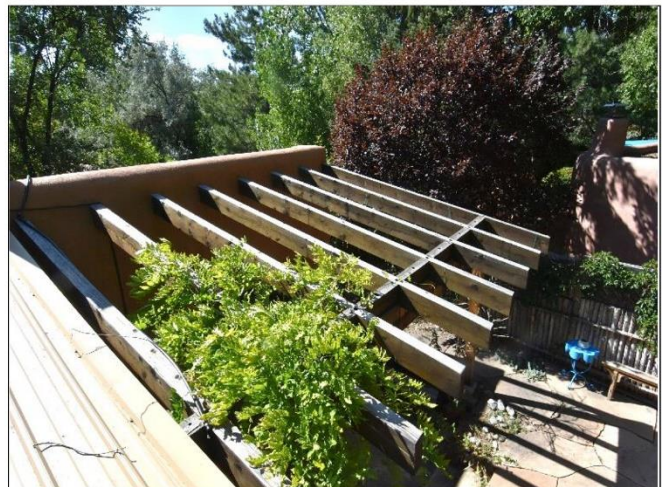
6. Exposed massive beams will need to be oil-sealed at least every 5-years.

7. Some of the fascia boards will need to be refinished with paint.
8. Exposed wood will need to be oil sealed at least every 5-years.
9. Rheem H₂O heater will need a safety pan installed underneath the tank.

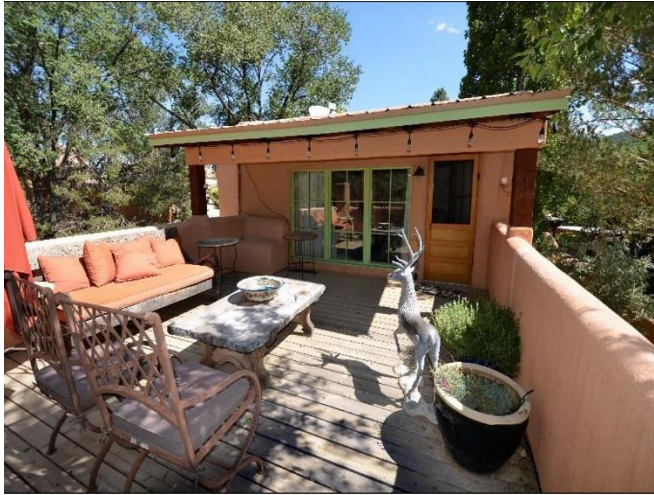
7. Upper enclosed Balcony with wood decking is in Satisfactory Condition.

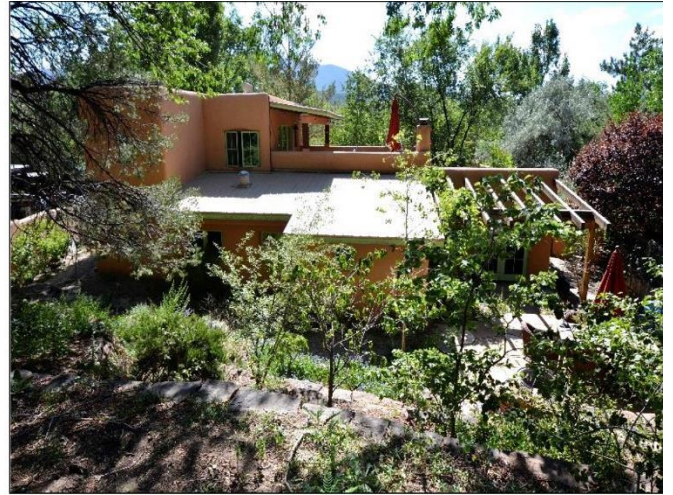
8. Overall gardens and Patios are in Satisfactory Condition.

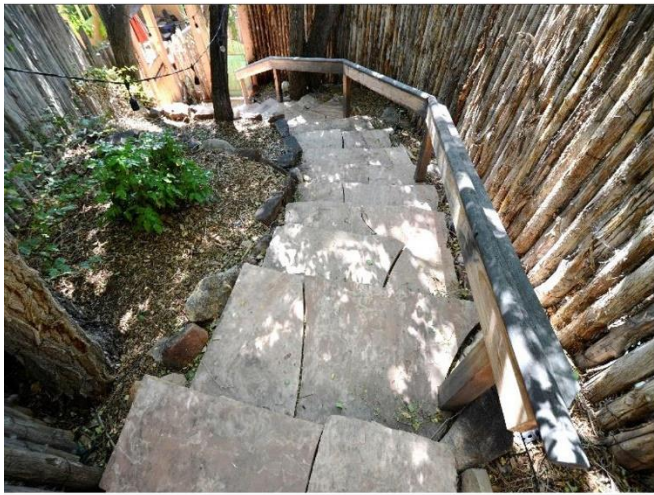
9. Flagstone stairs from the upper garden area is in Satisfactory Condition.

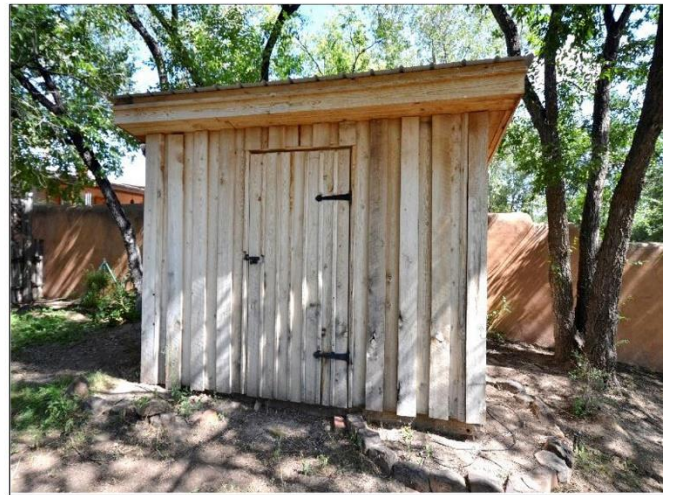
10. Garden tool shed board & batten is in Satisfactory Condition.

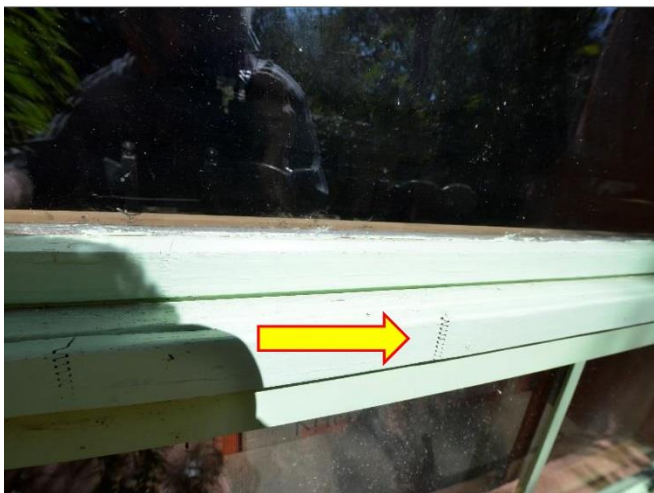
11. Some of the molding on the wood windows are showing finger joint dislodging and will need to be replaced and repainted.

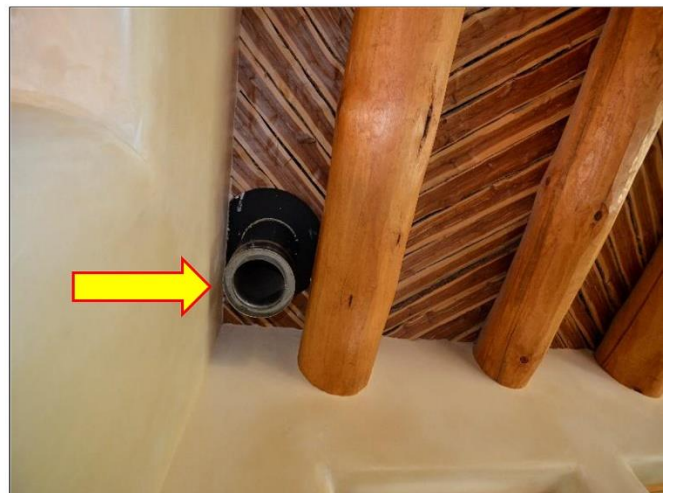
12. Wood burning metal flue should be covered underneath.

3. Two windowpanes were cracked and will need to be replaced.
4. Wood burning flue on the Living Room ceiling should have a cover plate added to prevent pest intrusion.

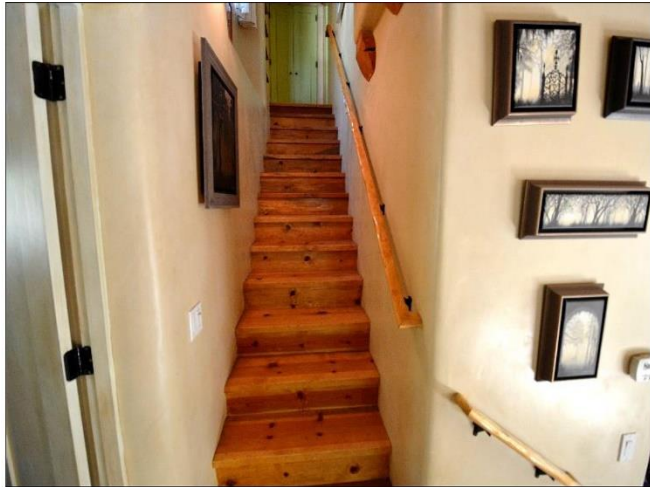
13. Wood staircase lower with single wood hand railing is in Satisfactory Condition.

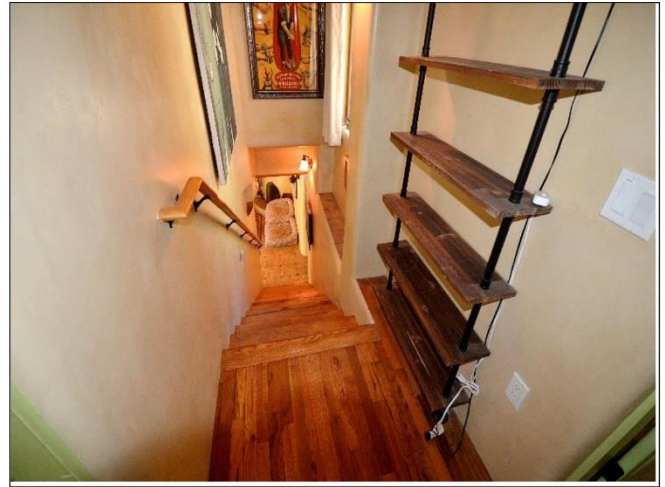
14. Wood staircase upper with single wood hand railing is in Satisfactory Condition

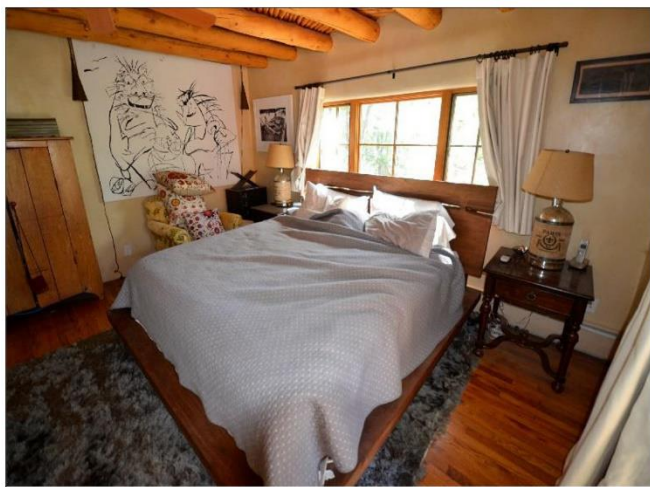
15. Master Suite Bedroom with wood floors, Vigas and decking is in Satisfactory Condition.

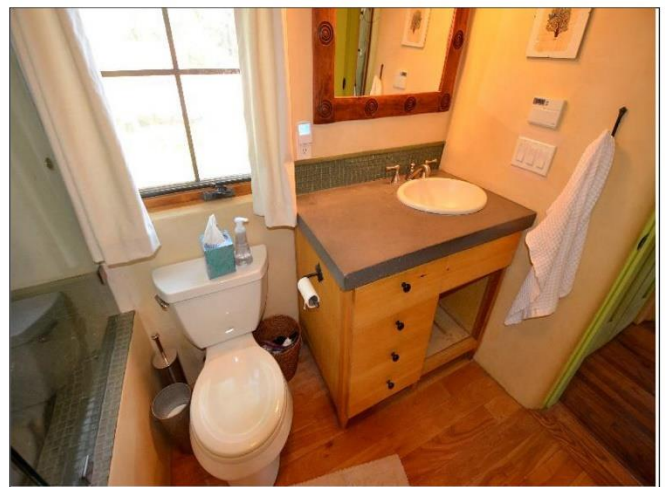
16. Master Bathroom with custom enclosed bathtub with tempered glass doors, Kohler toilet, sink and wood floors are in Satisfactory Condition.

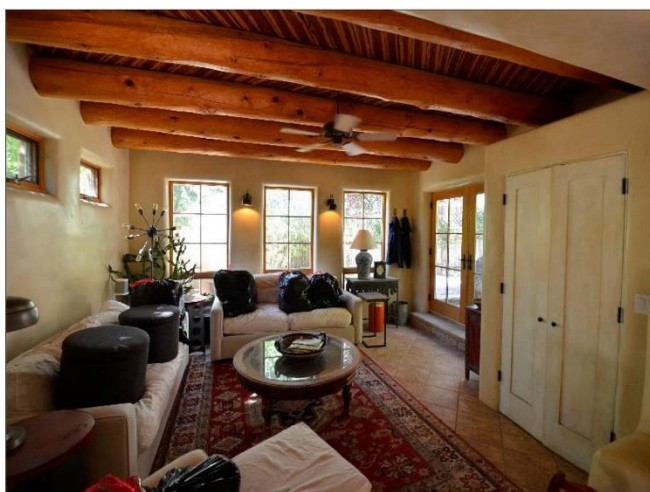
17. Living room with Vigas, herringbone latias and tile floors are in Satisfactory Condition.

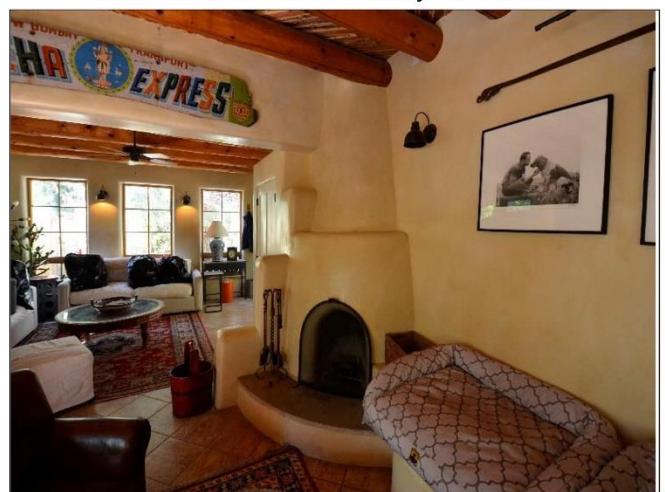
18. Sitting and Dining Rooms with Kiva Fireplace are in Satisfactory Condition.

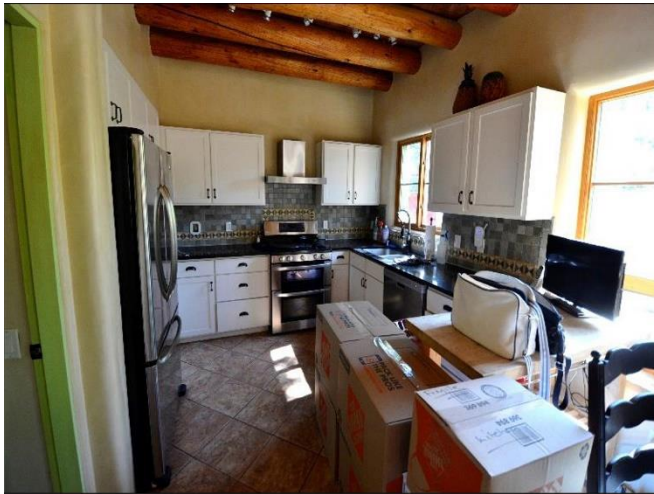
19. Kitchen with newer appliances, ceramic tile floors are in Satisfactory Condition.

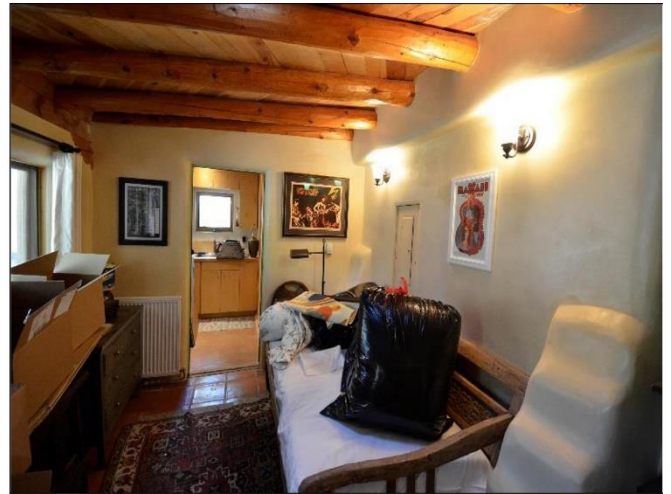
20. Office/ Utility area with Vigas and herringbone wood boards are in Satisfactory Condition.

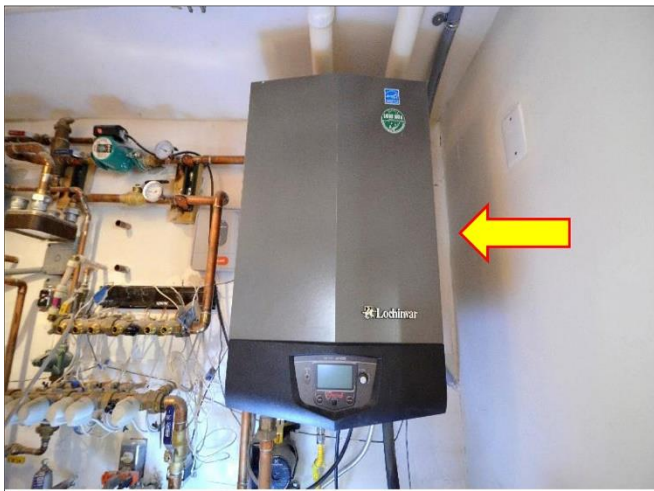
21. Lochinvar Instant H₂O heater for radiant heating was not working at the Inspection and will need to be operational before closing this Inspection.

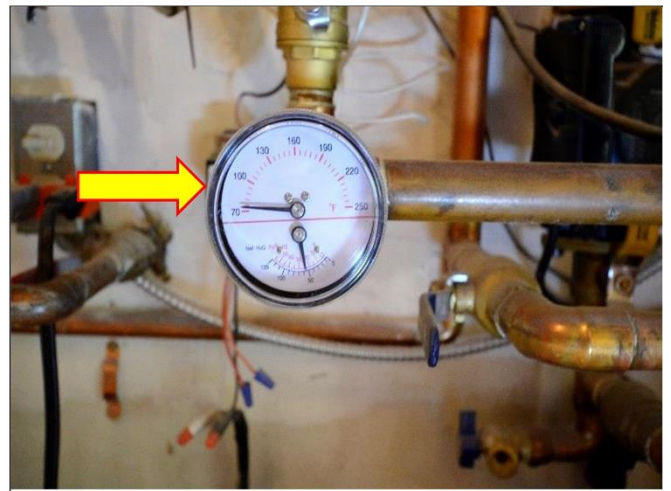
22. Pressure/ Temperature gauge was not registering until the Lochinvar Instant H₂O heater is working.

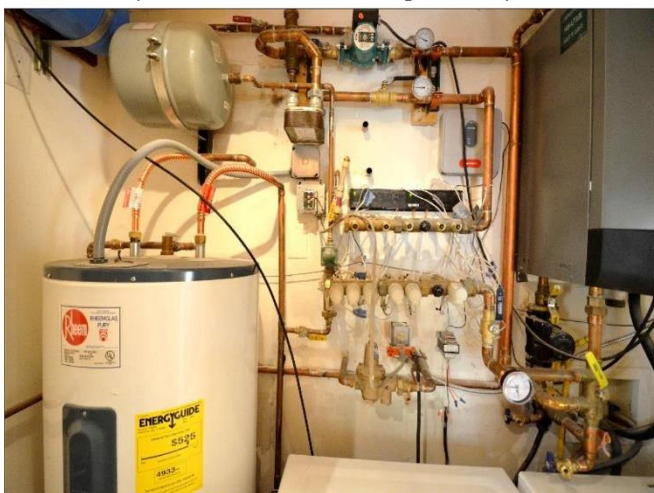
23. Rheem H₂O heater should have a safety pan provided under the tank.

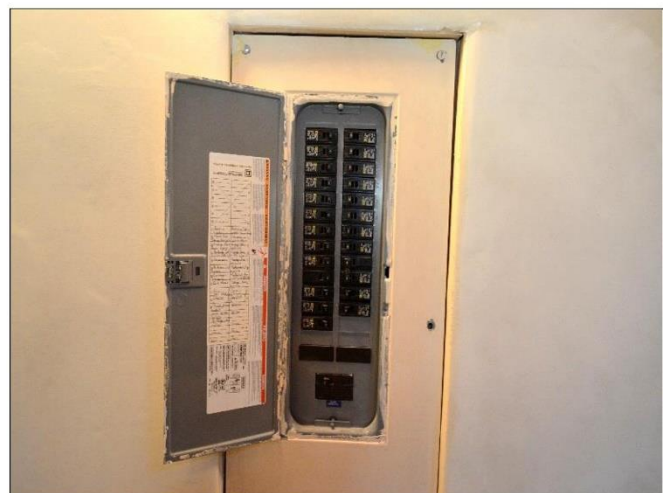
24. 100Amp Panel is safe and properly wired for the House.

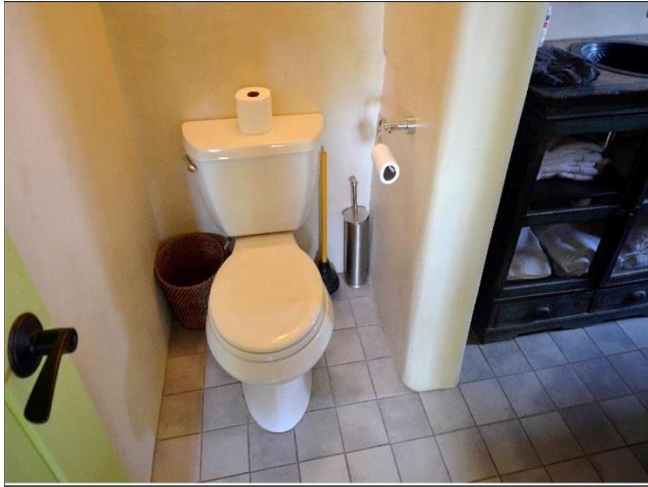
25. Downstairs bathroom with ceramic tile floors, Kohler toilet are in Satisfactory Condition.

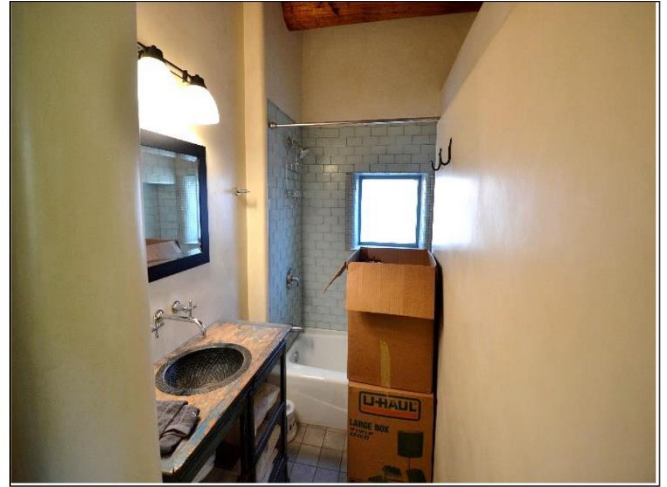
26. Downstairs bathroom with ceramic tile floors, Kohler bathtub and custom metal sink are in Satisfactory Condition.

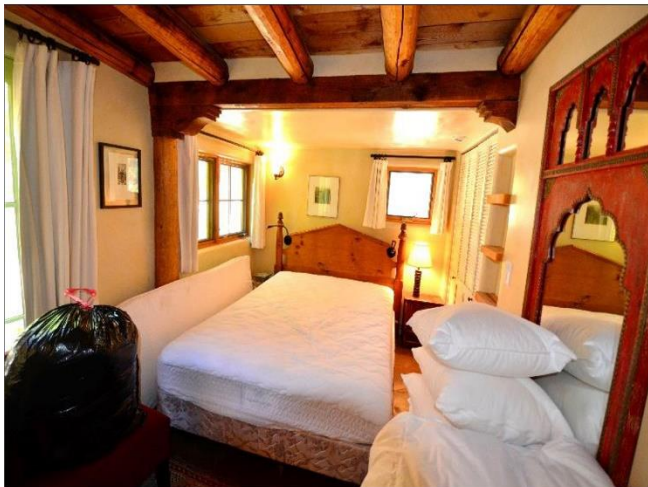
27. Downstairs Bedroom with Vigas, beam & corbels and polished concrete floors are in Satisfactory Condition.

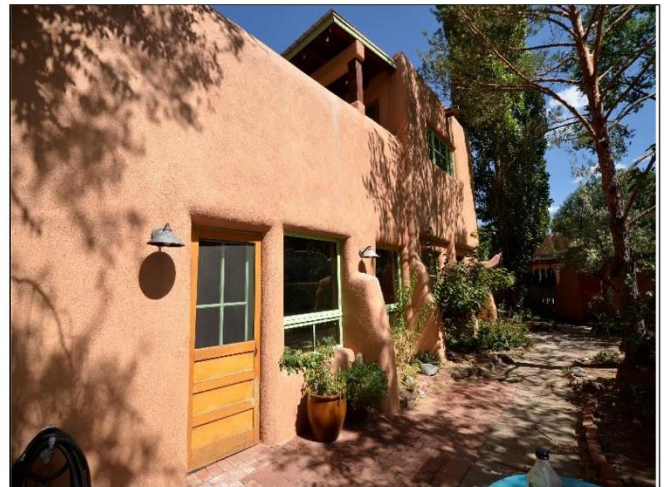
28. Front door Entry with flagstone patio pavers and stucco buttress walls are in Satisfactory Condition.

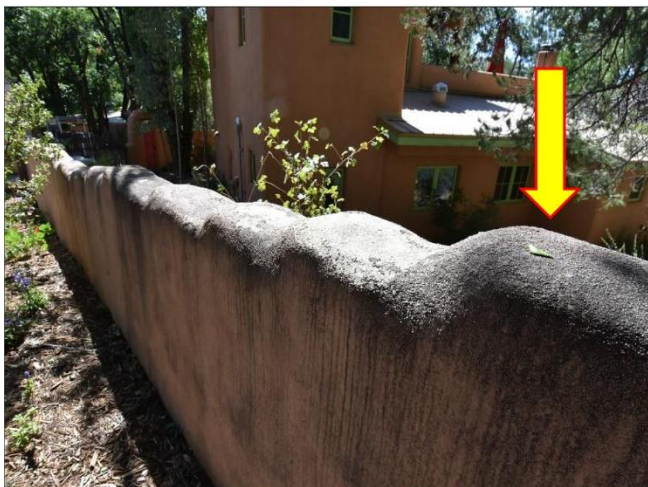
29. Garden Stucco walls are badly stained and will need to be resurfaced in time.

10. Coyote fencing is leaning in some places and will need to be re-braced.
11. Stucco garden walls will need minor patches and resurfacing.

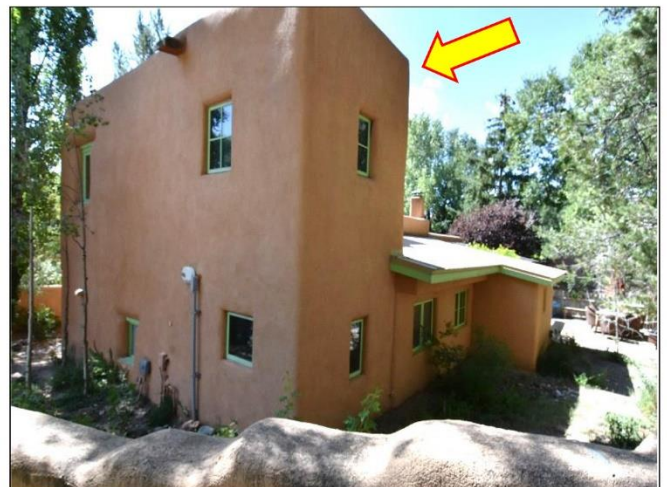
30. Two story portion of Adobe house, but the Master Bathroom is made of frame walls.
