CONDOMINIUM INSPECTION REPORT

Douglas Lynam

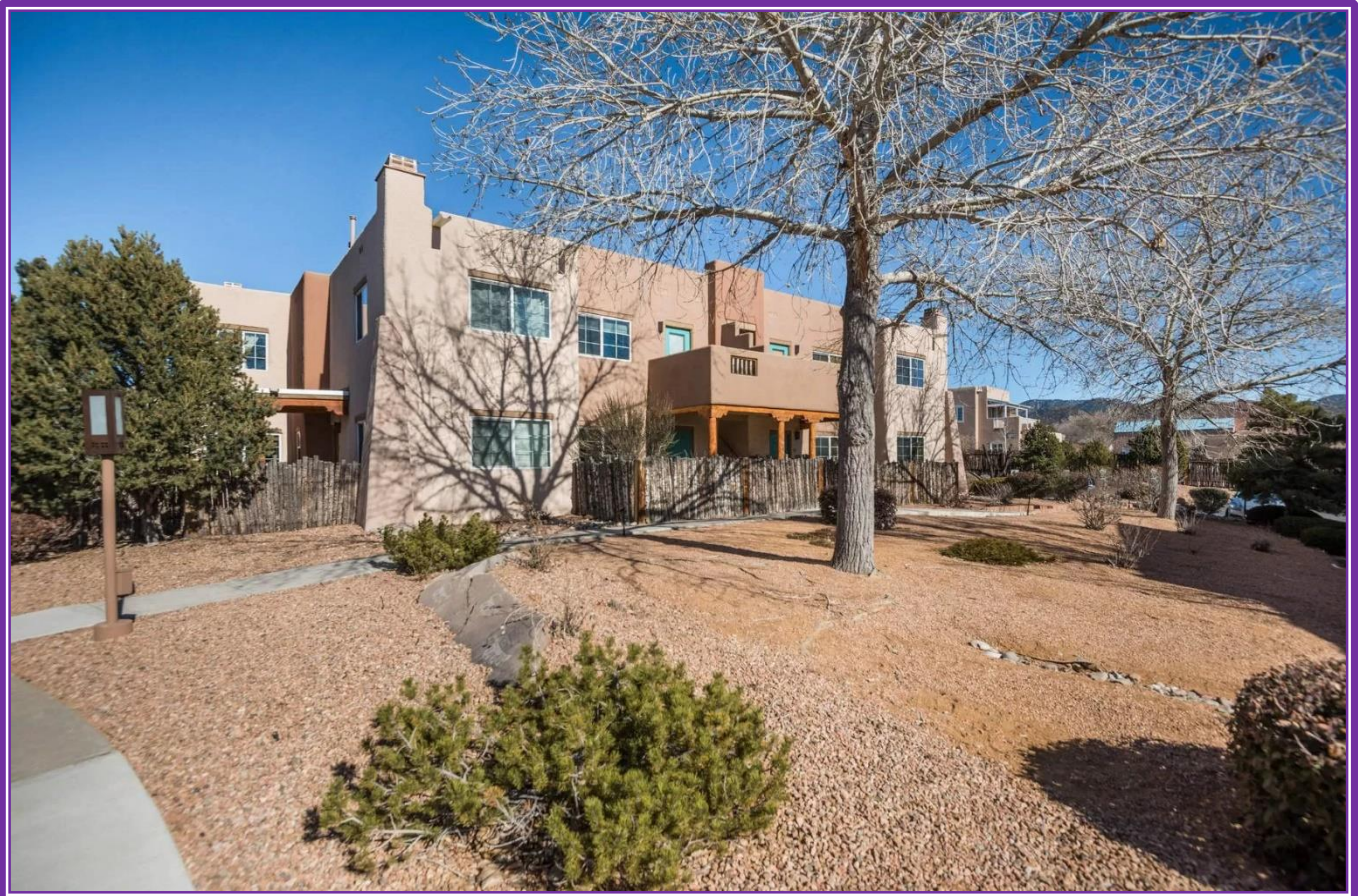
ActiveHome INSPECTIONS™

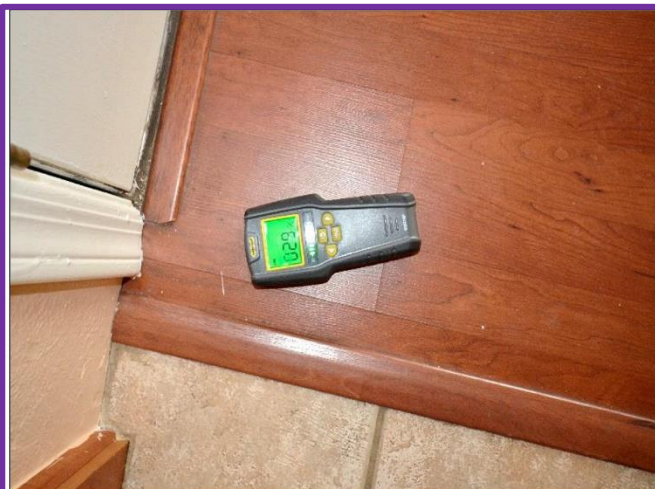
1. Moisture readings below 30% on the Pergo wood veneer flooring are normal to prevent mold growth under the composite wood with proper separation.

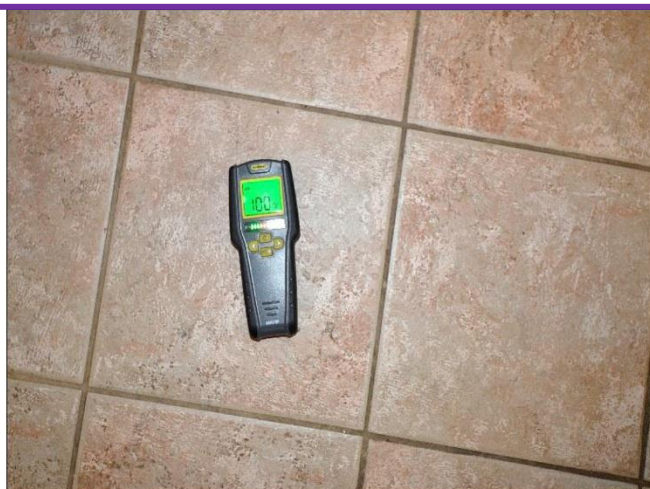
2. Moisture readings at 100% on the Kitchen ceramic tiles over the sub-concrete slabs demonstrates that there was no vapor barrier installed underneath.

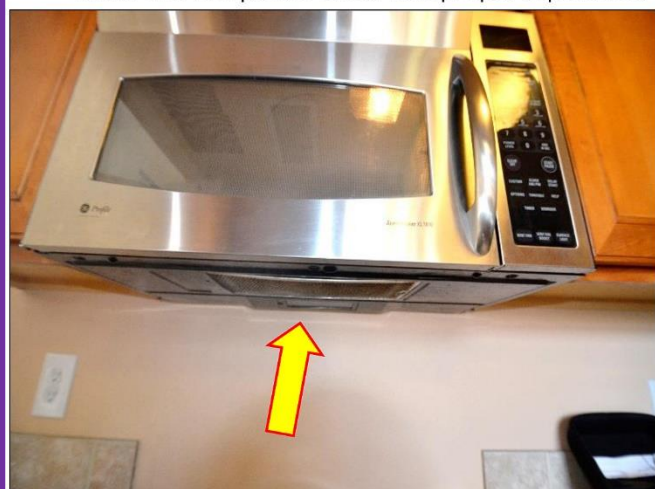
3. **GE** Microwave oven's surface lightbulb is **OUT** and will need to be **Replaced**.

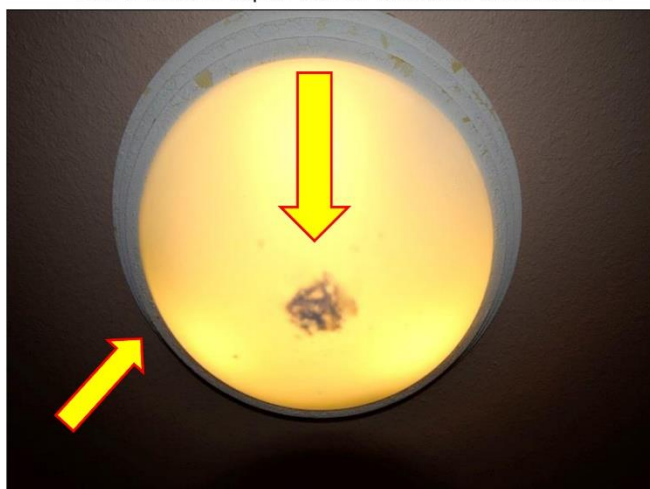
4. Kitchen ceiling light fixture will need to be removed and cleaned, but the Seller should instruct the Buyer on how to remove and replace the lightbulbs.

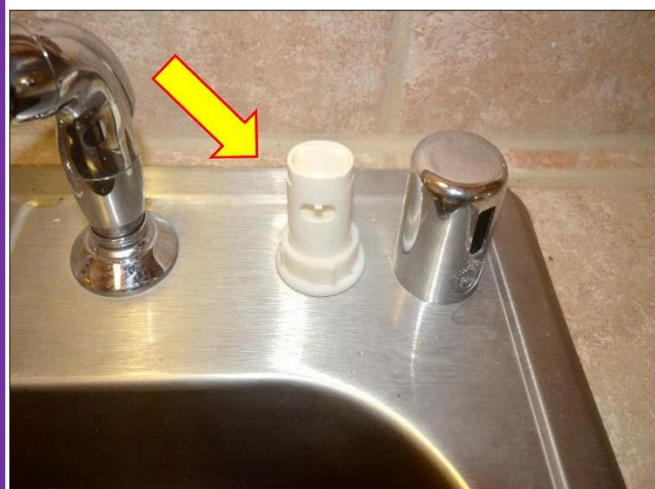
5. Kitchen sink's Air Gap is **LOOSE** and will need to be repaired by a Licensed Plumber.

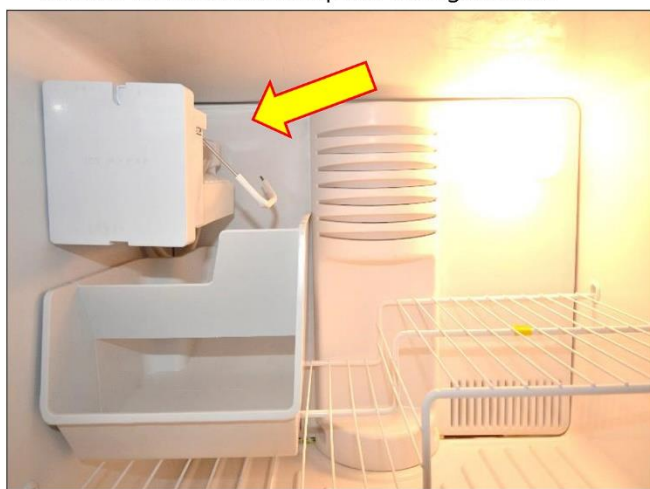
6. **GE** Refrigerator's Ice Maker is not properly hooked up, although there's 1/4" copper tubing found below the cabinet and above, it will need to be reestablished.

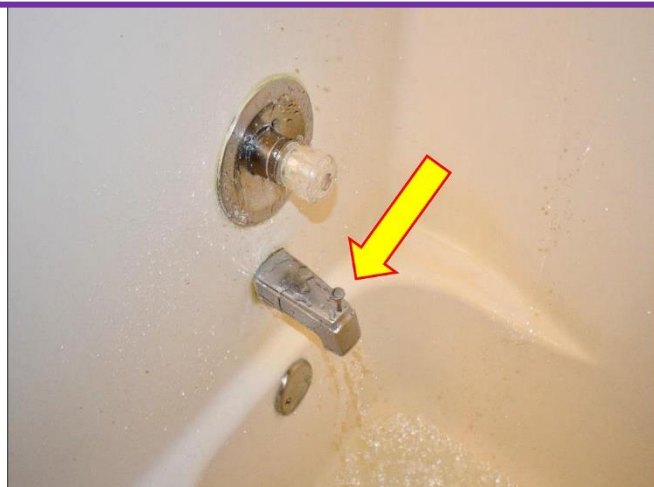
8. Bathroom **Delta** Bathtub/ Shower faucet is not properly working with the spout's diverter valve and it should be **Replaced**.

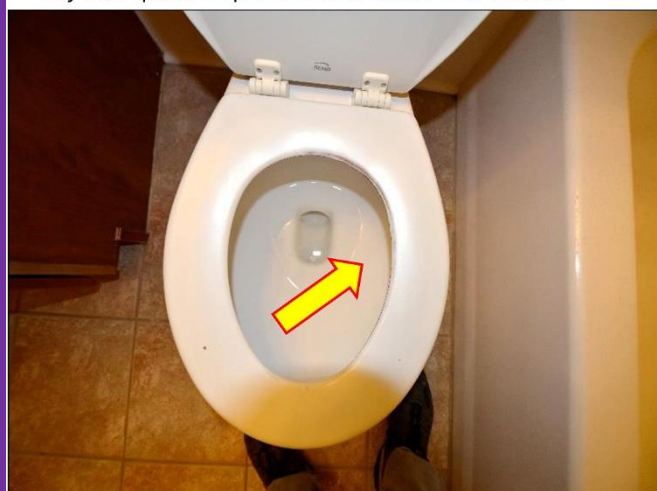
9. Bathroom **Mansfield** toilet seat is worn and should be **Replaced**.

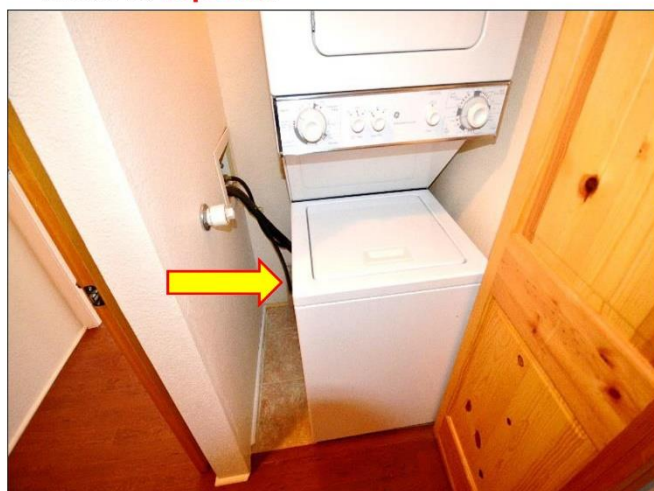
10. **GE** stacked Laundry washer & dryer's washing cycles are running squeaky and the washing machine will possibly need a new belt.

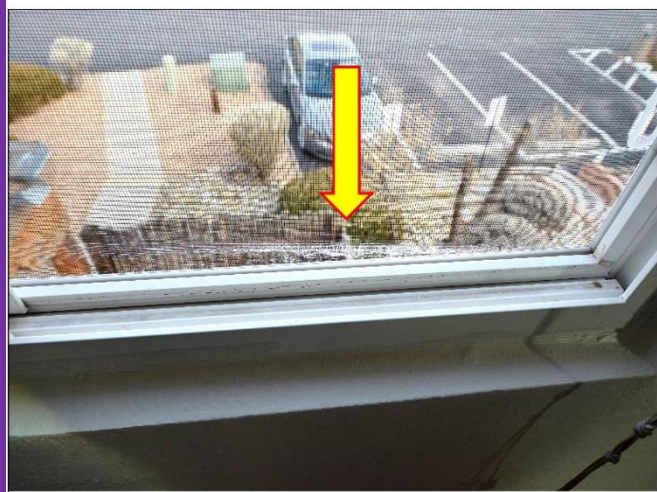
11. All the Window screens are worn or damaged should be rescreened.

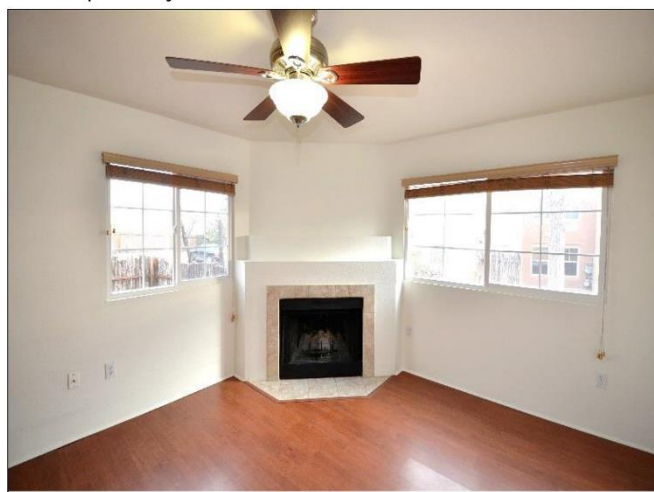
12. Living Room's Kiva Fireplace/ Ceiling Fan/ Pergo wood veneer flooring and the vinyl windows are in **Satisfactory Condition**.

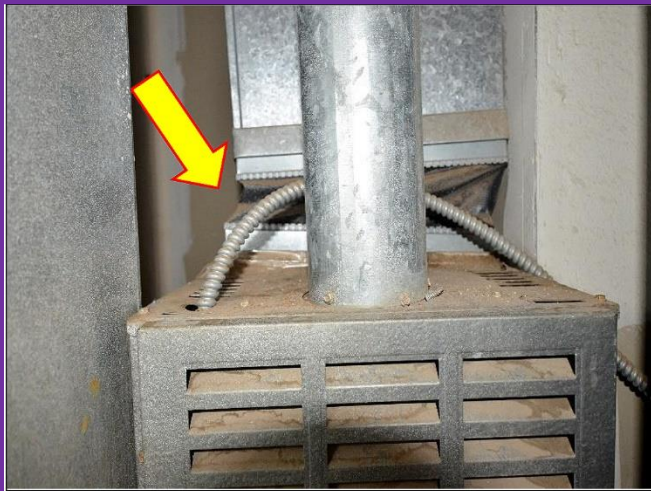
13. Plinth Jacket is **LOOSE** over the **Carrier** Furnace and will need to be immediately reset to prevent **Carbon Monoxide** poisoning.

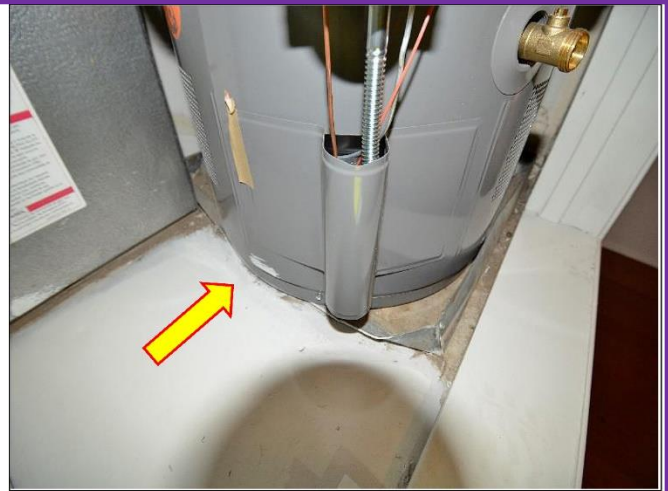
14. **Rheem** H₂O heater's safety pan is crushed and will need to be **Replaced** and drained to an outside or waste pipe source.

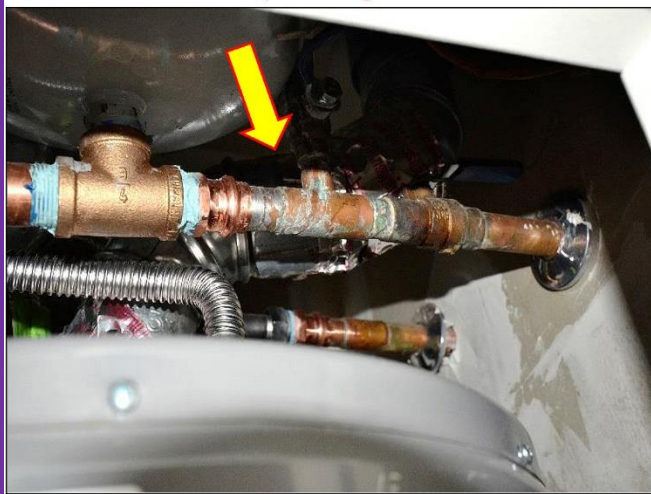
15. Valves and pipe connections above the **Rheem** H₂O heater are messy with possible pin leaks and this piping should be **Replaced** by a Licensed Plumber.

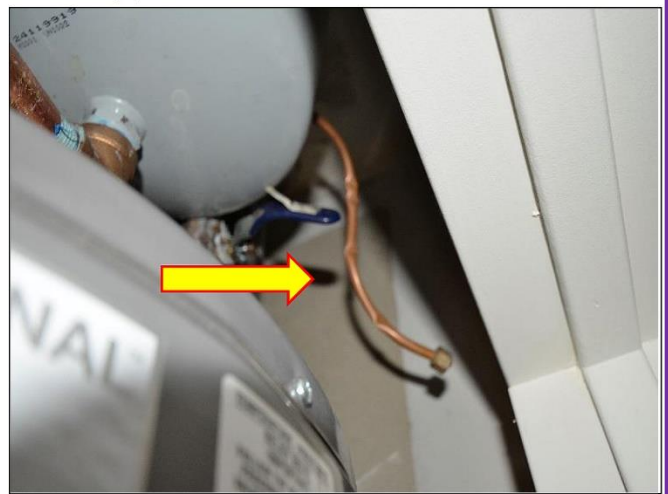
16. 1/4" copper tubing to the Swamp Cooler is crimped and should be **Replaced** and the **GE** Refrigerator's 1/4" copper tubing will need to be rerouted to ice maker.

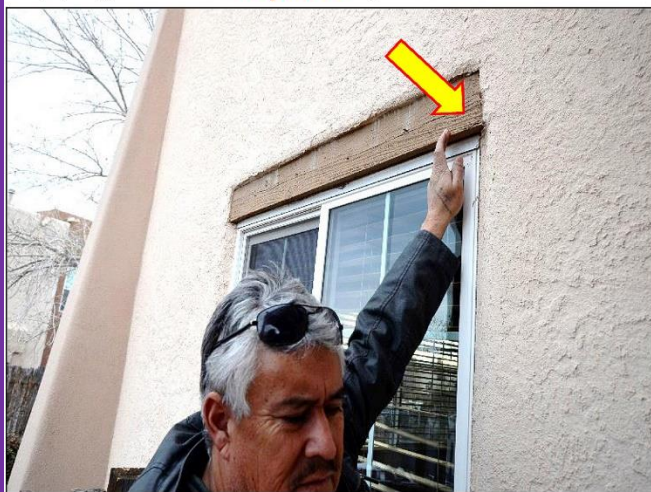
17. Exterior Header Trim boards are showing signs of rot and will need to be **Replaced** by the **HOA** Service & Management.

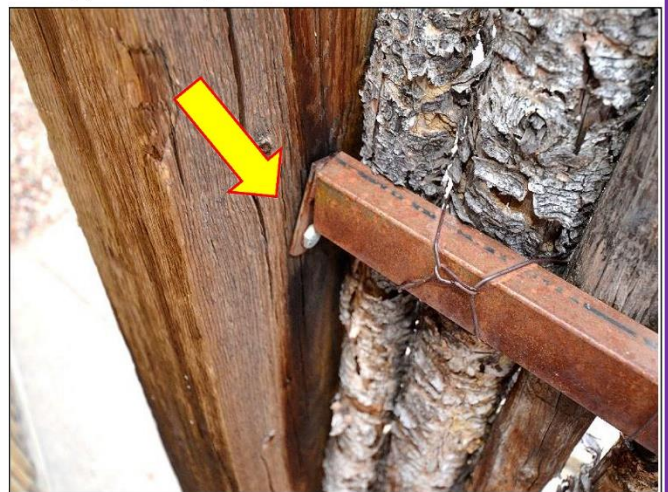
18. Coyote steel fence railing members will need to be secured & anchored to the posts by the **HOA** Service & Management.
